Softening and swelling mechanism affecting south slope of Civita di Bagnoregio (VT)

ABSTRACT: Civita di Bagnoregio is a small village in Central Italy, located on the top of a hill and affected by landslides that are progressively reducing the urban area. The access consists of a pedestrian bridge that connects Bagnoregio municipality to the village. The south slope beneath the bridge, is involved by frequent instability phenomena. This work describes the analysis carried out and it aimed at the definitions of geological and geotechnical mechanism affecting the above mentioned slope. A geotechnical survey has been carried out. These surveys showed the presence of a superficial layer, resulting from the softening and swelling of underlying clay-silty strongly overconsolidated, responsible for the superficial landslide phenomena. A slope stability and a 3D laser scanner model has been carried out. The analysis demonstrates that a correct design for the landscape preservation and consolidation of unstable towns needs an understanding of triggering mechanism and geotechnical properties of the involved soils.

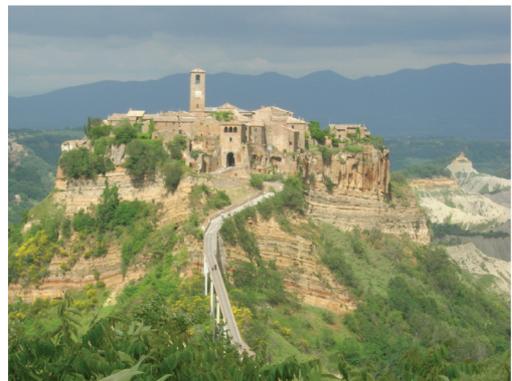
Figure 1. The site of Civita di Bagnoregio.

Civita di Bagnoregio (Fig. 1) is a small village whose origin dates back to Etruscan civilisation founded in Central Italy before roman empire (about VII century BC). It is located about 100 km north of Rome in the boundary between volcanic

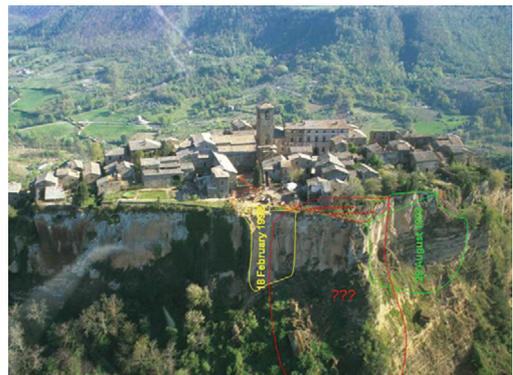
Figure 4. View of the northern side of the cliff and displaying recent phenomena and the of the joints (dotts) isolating an important rock slide (red).

retrogression of 6 m. Such failure represents the prosecution of the existing joint in Piazza del Vescovado, prolonged in West direction, under the damaged building (Fig. 4). This joint is isolating a huge rock slide, that need an immediate intervention.

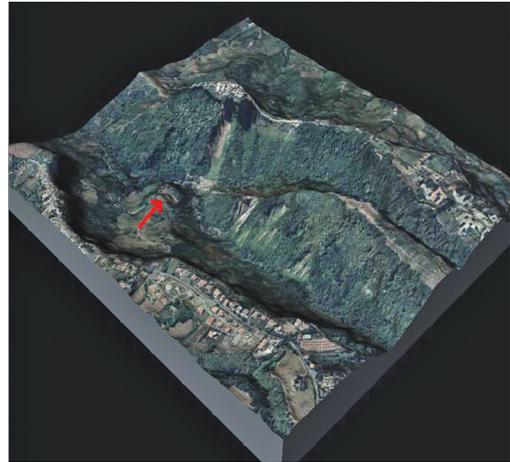
Figure 5. DEM of the area with superimposed an aerial photograph. In the left side it is possible to notice the toe of the large slide that, in 1114 A.D. moved the river from the natural linear behaviour towards the Civita cliff, Northern sector.

The acceleration of geomorphological processes in the Northern cliff can be associated, likely, with a large events that occurred in other side of the valley, dated about 1114 A.D. (Fig. 5). This event, clearly visible on the field, moved the river closer to Civita, producing an higher energy relief on this part of the valley.

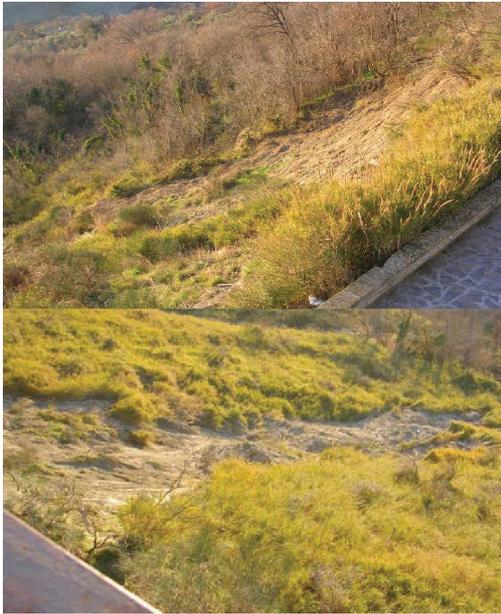
Figure 6. Earth flows along the south slope—December 2008.

The main instability present along the slopes of the south side, subject of this study, is a phenomenon that has characterized the past evolution of this side and that was reactivated substantially in December 2008 and in March 2010 by heavy and prolonged rains reaching the current quiescent configuration as evidenced by the photographic survey follows. (Fig. 6)

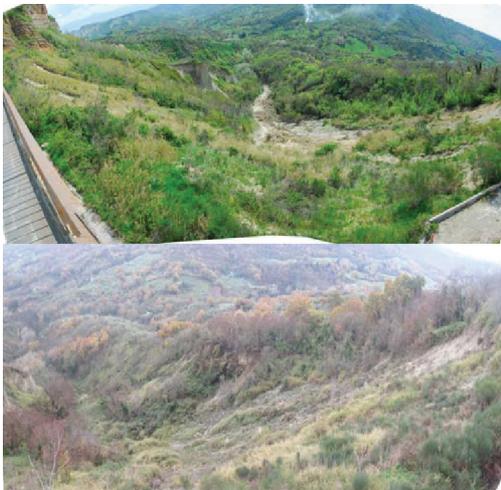
Figure 7. Reactivation flows along the south slope—March 2010 and the present.

Below is reported the photographic survey of the second reactivation (March 2010) and the present situation (December/January 2011) (Fig. 7).

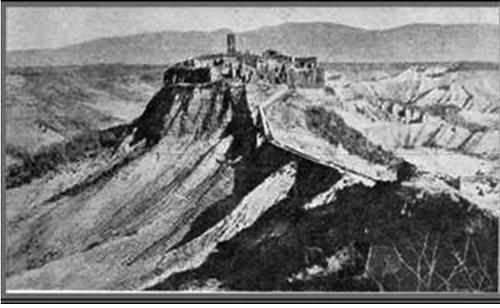
Figure 10. Civita di Bagnoregio access morphological saddle: anti-erosional works in 1948.

photos testifying the consolidation works developed along time (Fig. 10).

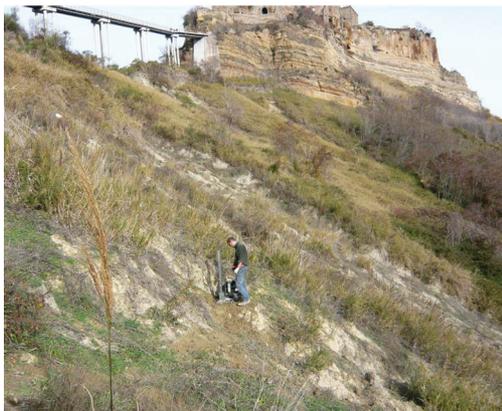
Figure 14. DPM penetration tests: site not easily accessible.

The choice of the investigation was influenced by the presence of trees, slope steepness and instability that did not allow the use of heavier equipment.
