Giuseppe Delmonaco⁽¹⁾, Fabio Garbin ⁽²⁾, Maria Marsella⁽³⁾, Claudio Margottini ⁽¹⁾, Alberico Sonnessa ⁽⁴⁾, Daniele Spizzichino ⁽¹⁾

Laser scanning analysis and landslide risk assessment on transportation network: the Lugnano in Teverina (Umbria Region, Italy), landslide case study

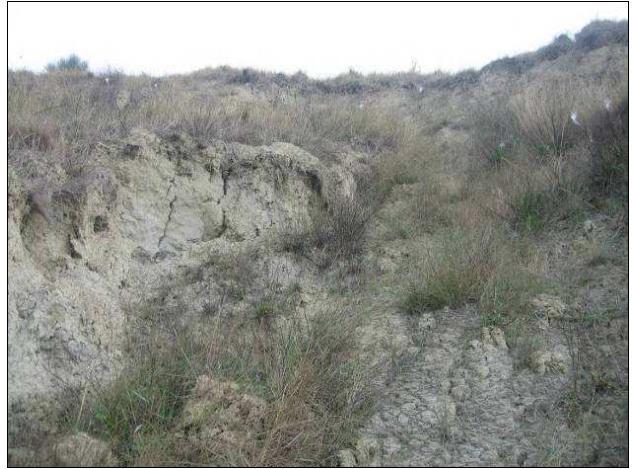
Figure 2 Detail of the crown area of Lugnano landslide

The outcropping of weak clayey rocks and superficial water circulation are the most important causative factors for landslides whereas heavy precipitation is the main triggering factor, causing the decaying of shear strength parameters of the clays. The main landslide types, affecting the study area, are rotational and translational slides (Cruden and Varnes, 1996), in the upper portion of the slopes, evolving in mud/earth-flows (Cruden, 1991.), in the middle-low parts (Fig.2 - 3).

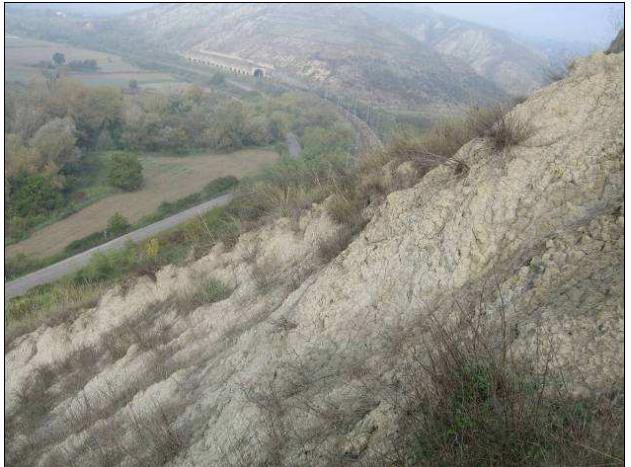
Figure 3 Middle portion of the landslide

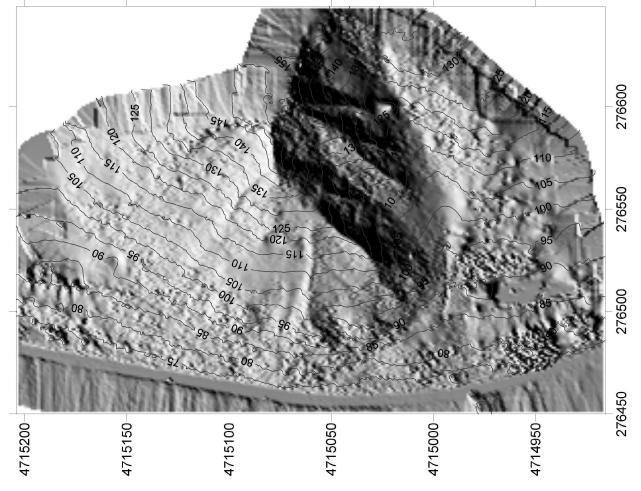
Figure 4 Pre event laser scanning 3D model of the Ramici Landslide

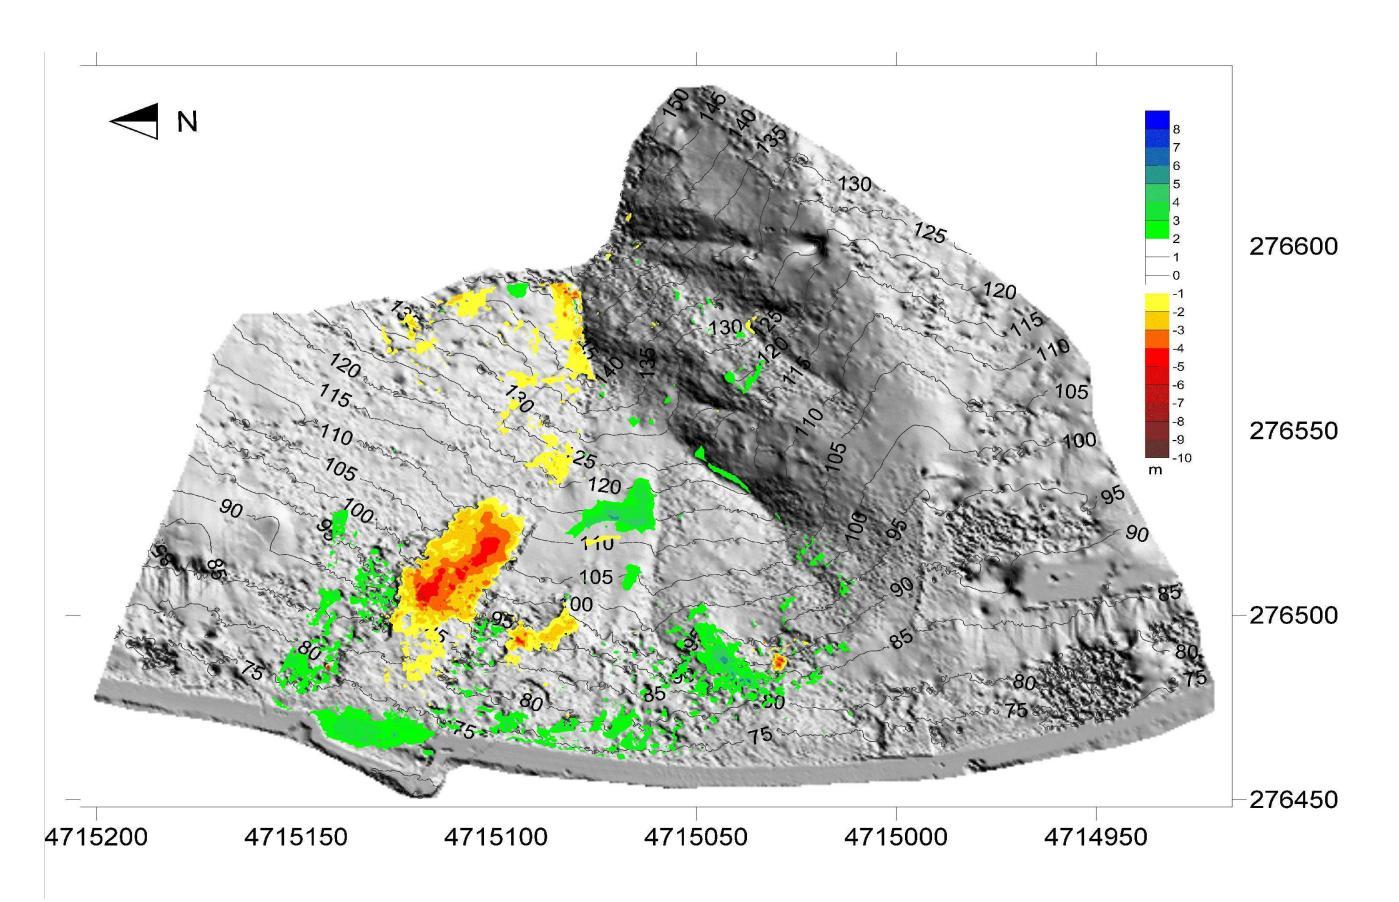
Figure 6 Estimation on mobilized volume during the May 2010 event Slope stability analysis affect

Laser scanning surveying were performed to accurately map the landslide geometry and estimate the involved volumes (Heritage and Large, 2009) . The collected data allowed to extract a Digital Terrain Model of the landslide body after having removed artefacts and sparse vegetation form laser point clouds. Such a model (Fig 4) was obtained at the beginning of investigations for a detailed description of the area aimed at assessing the landslide area and volume as well at precisely locating the potential surrounding interference with the failure, such as the railway tunnel and the provincial road 87. After the 15-16 May 2010 event, the Municipality of Lugnano in Teverina, commissioned a new laser scanning investigation, for the reconstruction of postevent morphology (Fig. 5). To estimate the volumes remobilised by landslides (Delmonaco et alli, 2006) the differences between pre and post DTMs were analysed (Fig. 6). The analysis of the post event DTM permitted to verify the interaction between the new landslide body and railway and road network (Fig. 7).

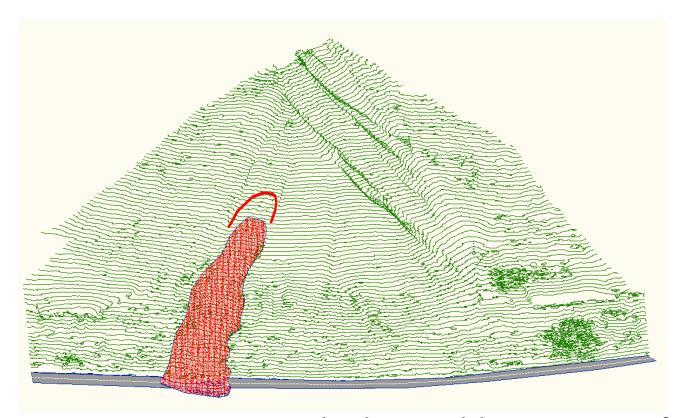
Figure 8 Topographical 3D model reconstruction for the stability model

Reference cross sections for the implementation of slope stability analysis have been extrapolated from the two 3D model. A post-event back-analysis calibrated on landslide sections, derived by high-resolution DTM (fig. 8), has provided actual shear-strength parameters, mobilised during the event along the failure surface. Giuseppe Delmonaco, Fabio Garbin , Maria Marsella, Claudio Margottini , Alberico Sonnessa , Daniele Spizzichino - Laser scanning analysis and LRA on transportation network

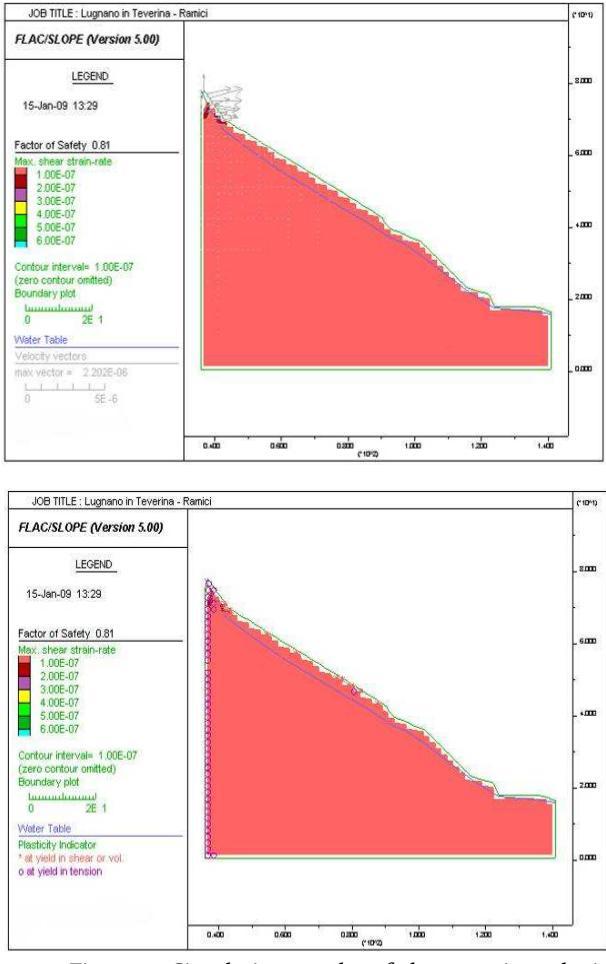
The safety factor for the above condition drops to 0.81. Shear strain and maximum value zone of velocity are distributed along the present failure surface (Fig. 10). The crown area of the landslide n. 2, that has been reactivated in May 2010, has resulted as the most critical situation according to numerical analysis. The model has substantially verified the observations made during the geomorphological analysis undertaken before the rainfall event of 15-16 May 2010 and the implementation of the slope stability analysis that detected the middle-lower part as the most hazardous sector of the slope. This situation has to be correlated with the highest thickness of remobilised material with very bad geotechnical characteristics, also under dry condition. The analysis has also defined the residual risk of the slope and addressed the choice of engineering solutions designed for the stabilisation of the landslide body taking into account the

Figure 10 Simulation results of shear strain, velocity and plasticity under partially saturated condition

The second iteration has been undertaken considering a realistic 70% saturation of the clayey landslide deposit. In the upper part of the slope, near the crown area, the depth of water level is on the contact between clay bedrock and superficial clays, simulating a saturation of materials from the bottom to the top surface. This is due the presence of tension-cracks, surveyed uphill, that promote water infiltration inside the landslide body, and potential pore-pressure generation along an assumed multiple landslide failure surface, located at ca. 130m a.s.l. and 1.0-1.5 depth.
